**LAKE POWELL  
RESIDENTIAL GOLF  
COMMUNITY DEVELOPMENT  
DISTRICT**

**BOARD OF SUPERVISORS  
REGULAR MEETING  
AGENDA**

**FLORIDA DEPARTMENT OF TRANSPORTATION**  
**BRIDGE MANAGEMENT SYSTEM**  
**Inspection/CIDR/Bridge Profile Report**  
**Inspection**

BRIDGE NO: 460167  
COUNTY: Walton  
FACILITY CARRIED: Wild Heron Way  
FEATURE INTERSECTED: Powell Lake  
LOCATION: 0.3 Miles N of SR30A/US98

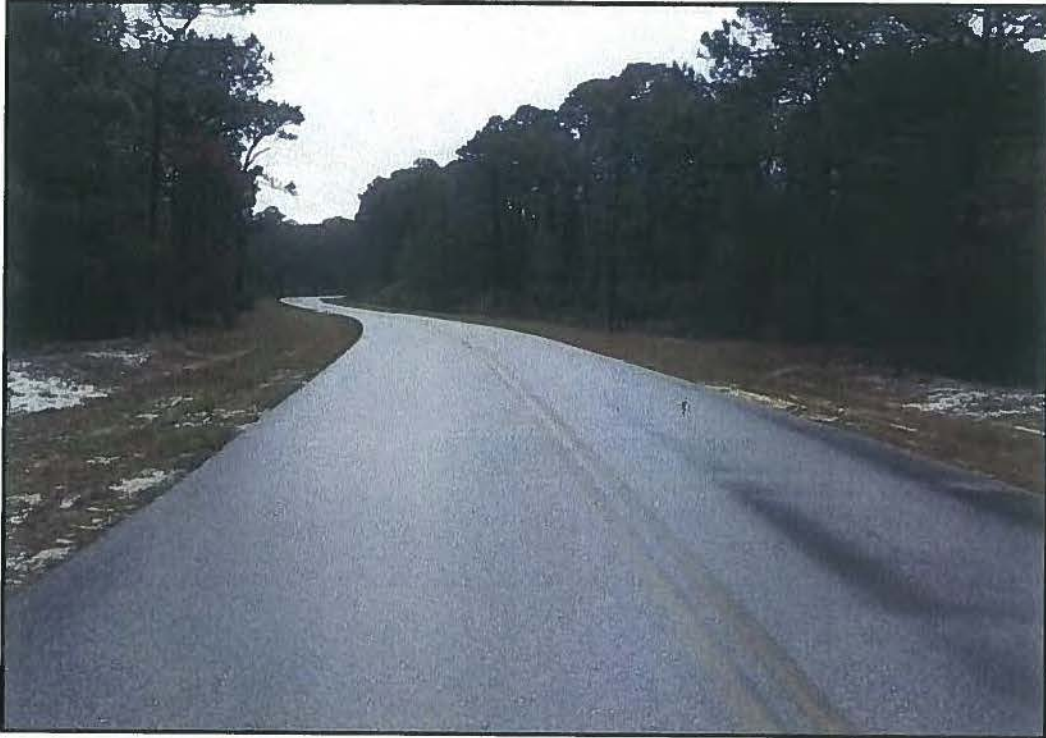
**WILD HERON WAY – 0.37 MILES SOUTH OF GUARD STATION  
LOOKING NORTH**

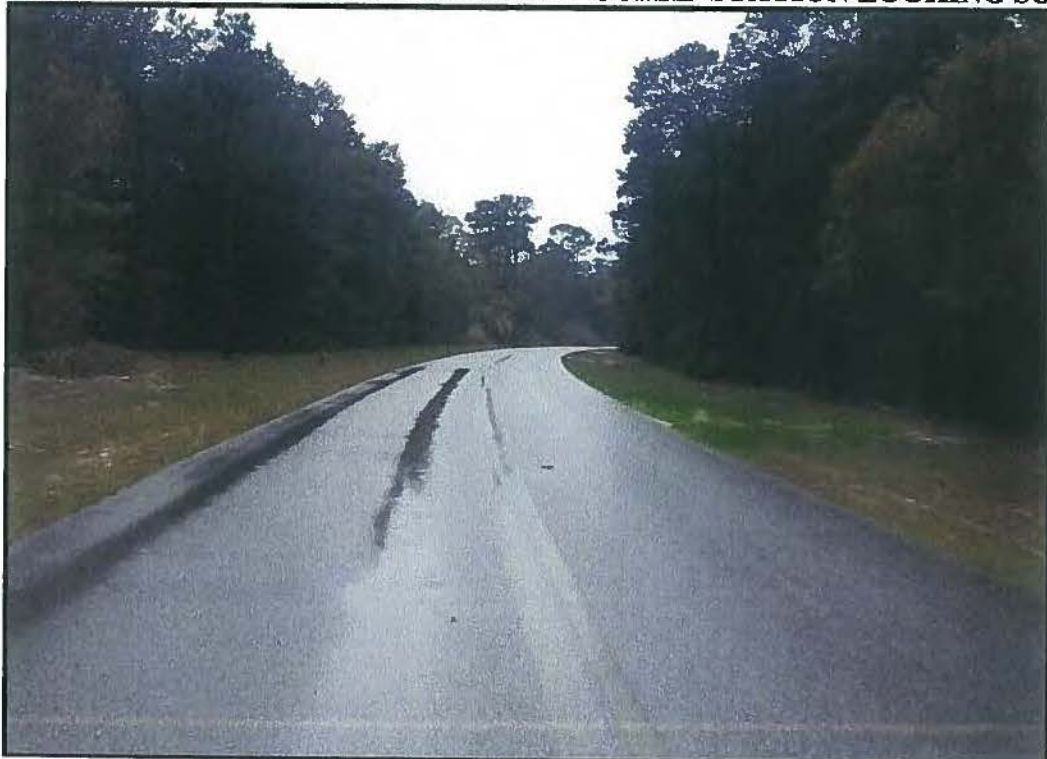
**WILD HERON WAY – 0.37 MILES SOUTH OF GUARD STATION LOOKING SOUTH**

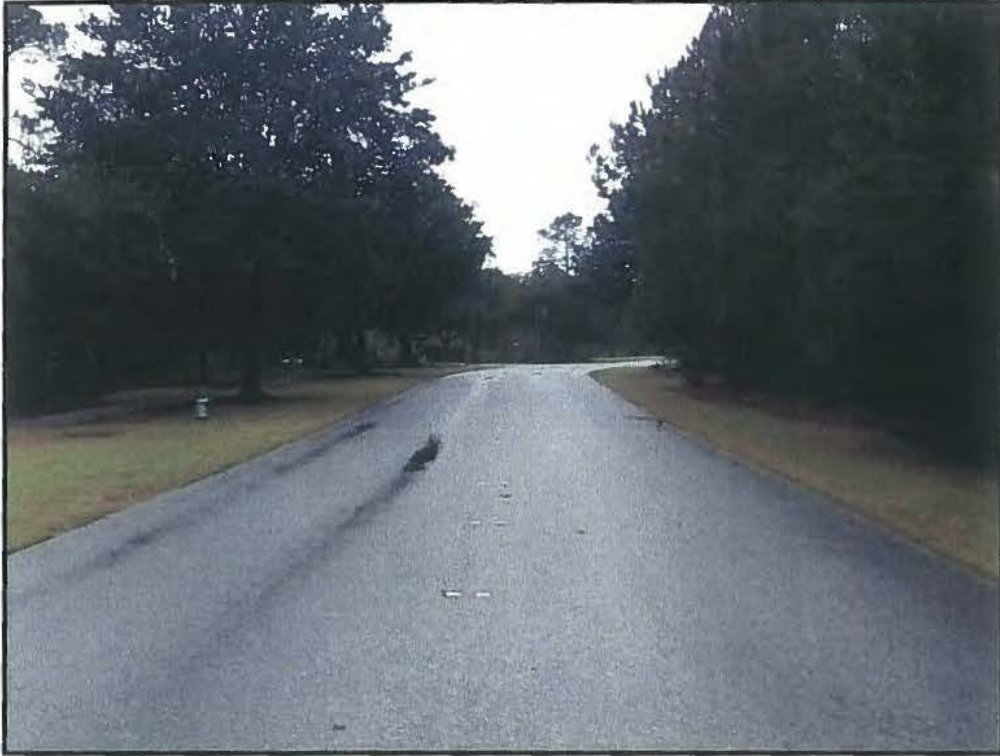
**WILD HERON WAY – 0.72 MILES NORTH / WEST OF GUARD STATION  
LOOKING WEST**

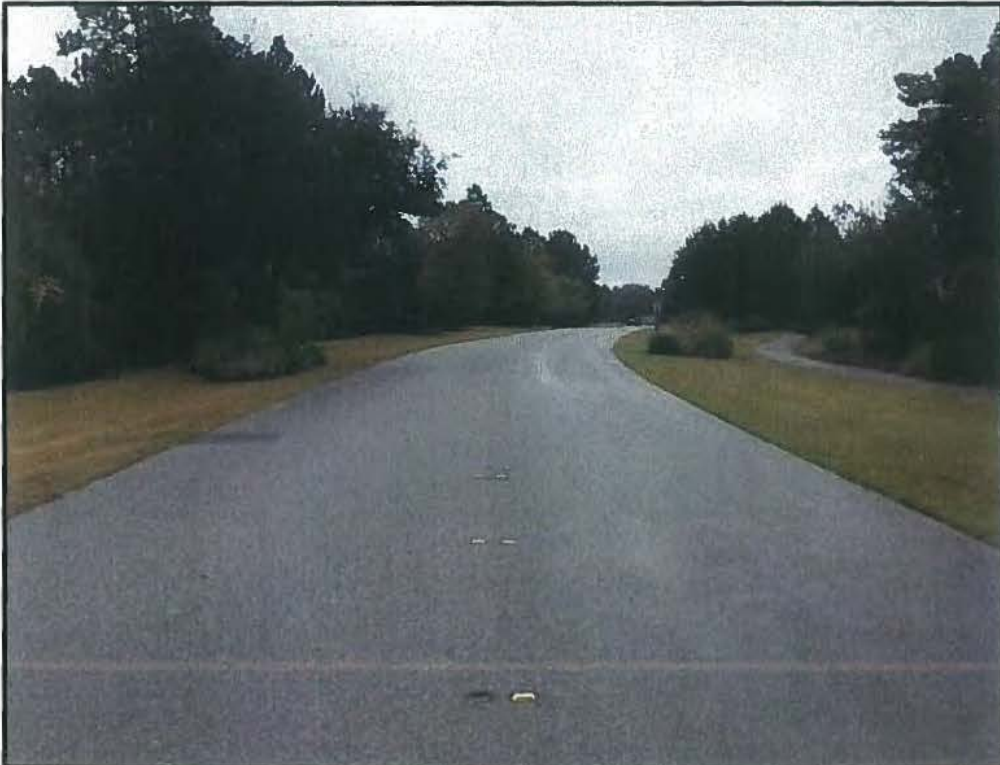
**WILD HERON WAY – 0.72 MILES NORTH / WEST OF GUARD STATION  
LOOKING EAST**

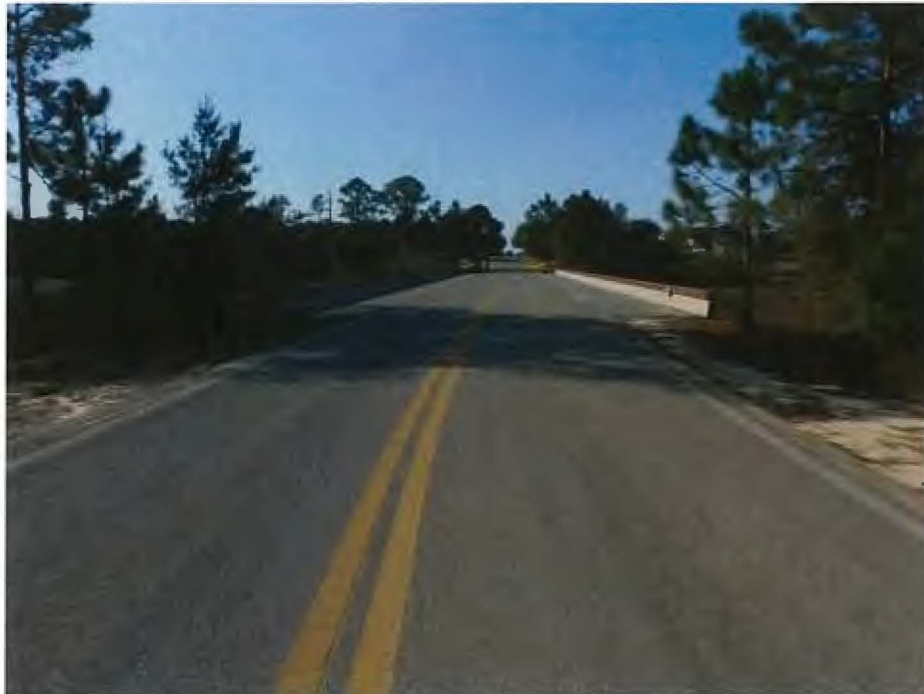
**12 - Re Concrete Deck**

Photo 1: Approach guardrails and object markers are not provided

CONDITION STATE		PRIORITY
1, 2	MMS Quantity: 1 sf    Element Estimated Quantity: 1 sq.ft	3
WORK ORDER RECOMMENDATION: Approach guardrails; install rail system to meet current state standards.		
1, 2	MMS Quantity: 1 sf    Element Estimated Quantity: 1 sq.ft	3
WORK ORDER RECOMMENDATION: Object markers; install at all four bridge corners.

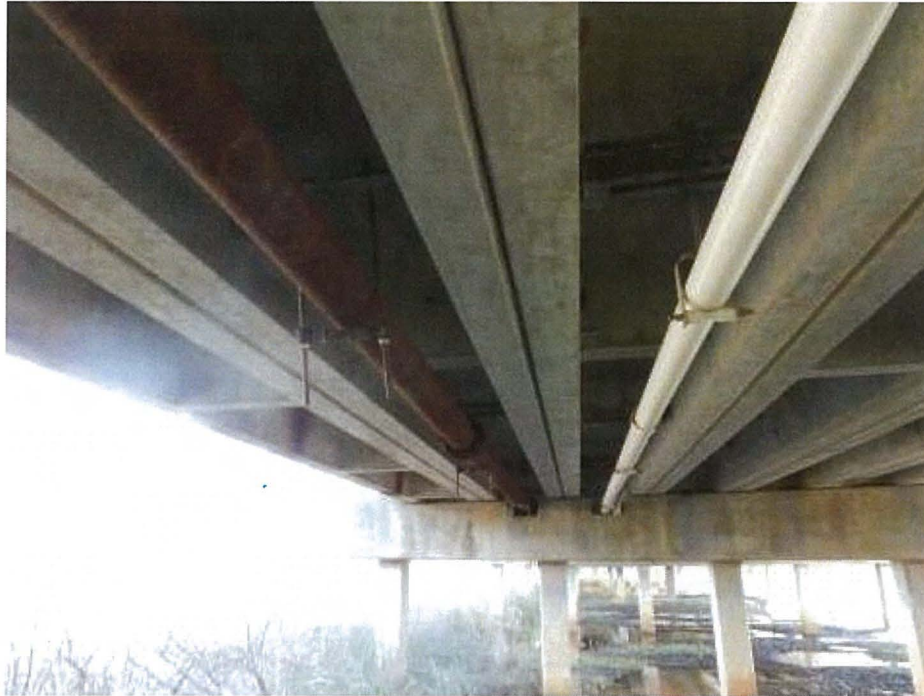
**12 - Re Concrete Deck**

Photo 3: Typical utility pipe along deck underside

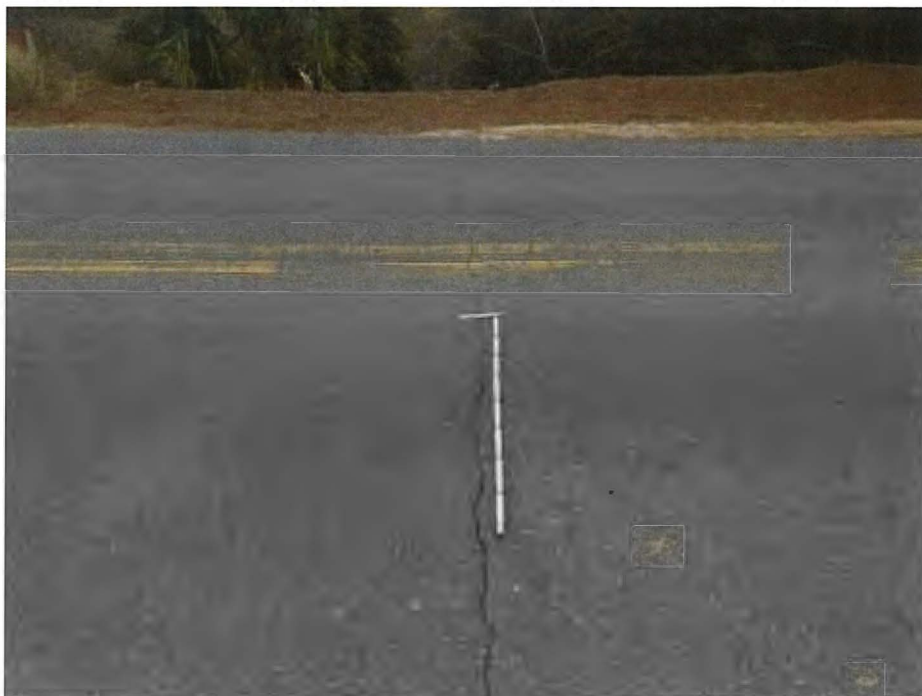
**321 - Re Conc Approach Slab**

1) There are transverse cracks, full length x 0.13 in W, at both roadway/approach slab transitions (See Photo 5).

Photo 5: Typical crack at approach roadway/slab transition

CONDITION STATE		PRIORITY
1	MMS Quantity: 1 sf    Element Estimated Quantity: 1 sq.ft	3
WORK ORDER RECOMMENDATION: Approach roadway/slab transition; seal transvers cracks.

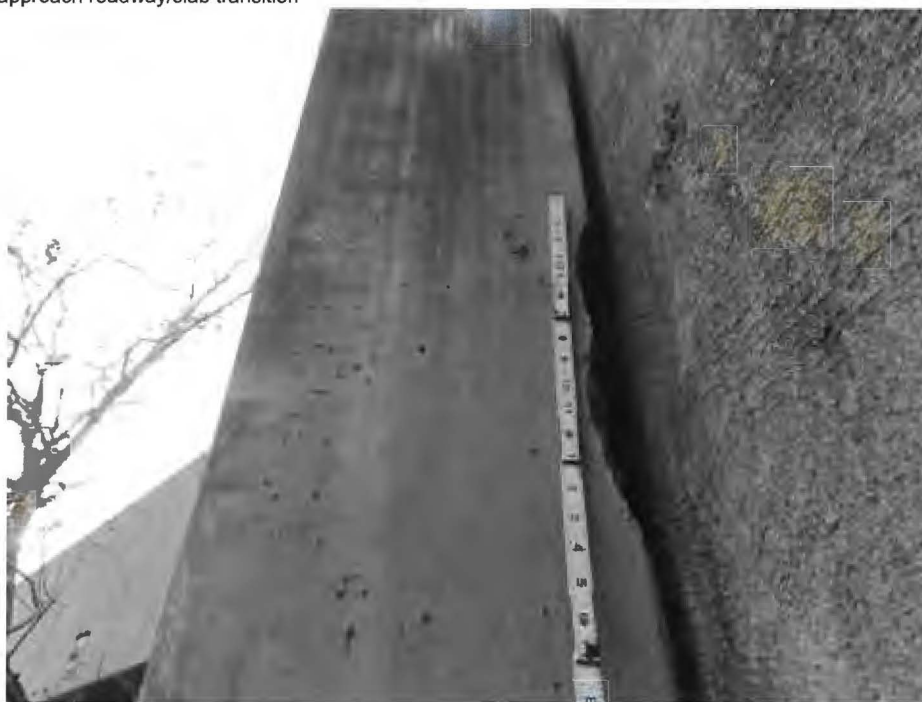
**8475 - R/Conc Walls**

1) The near left wingwall has a spall, 1.67 ft H x 0.21 ft W x 0.08 ft D, in the far right corner of the third pile (See Photo 6). (1080 - 1 FT)

2) The near left wingwall has a spall, 1.17 ft H x 0.42 ft W x 0.21 ft D, in the top southwest corner of the fourth pile (See Photo 6). (1080 - 1 FT)

Photo 6: Typical spall in near left wingwall pile

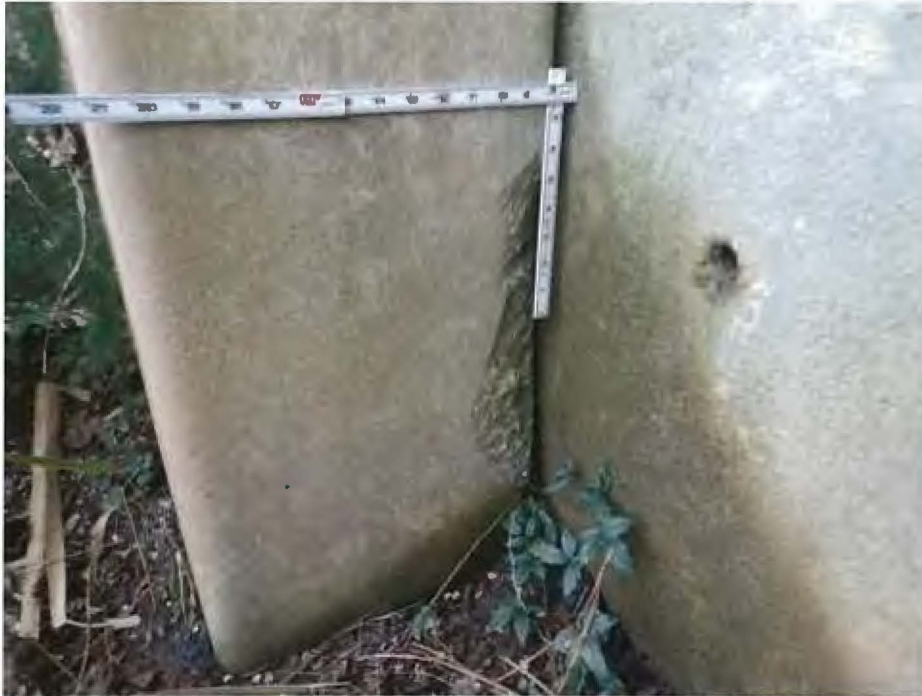
**8475 - R/Conc Walls**

3) The near right wingwall has a spall, 1.0 ft H x 0.29 ft W x 0.13 ft D, in the near left corner of the fourth pile (See Photo 7). (1080 - 1 FT)

Photo 7: Spall in near right wingwall pile

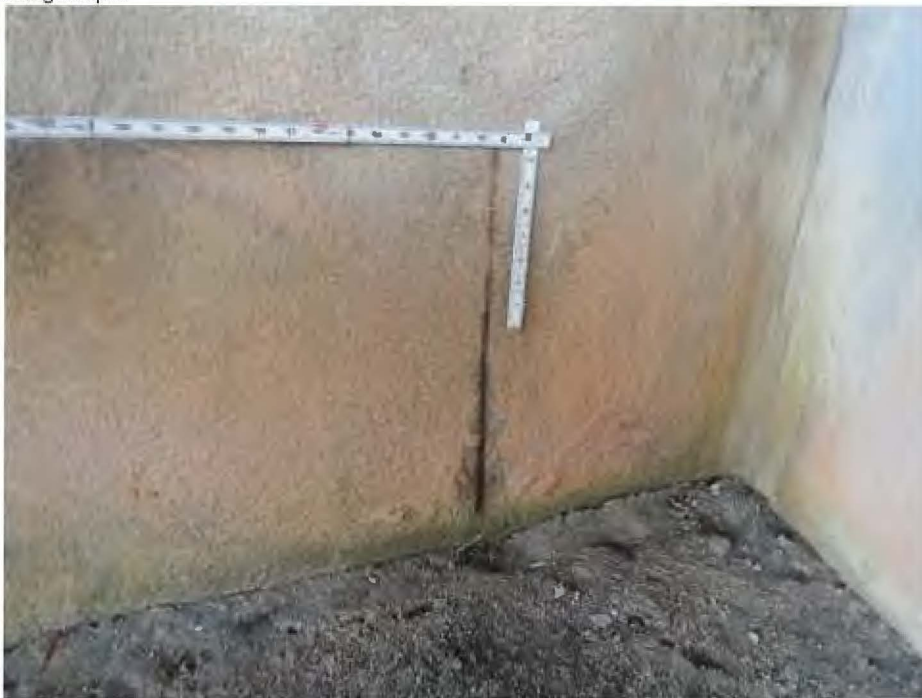
**215 - Re Conc Abutment**

1) The near backwall has a spall, 1.5 ft H x 0.17 ft W x 0.25 in D, with exposed steel due to insufficient cover (See Photo 8). (1080 - 1 FT)

Photo 8: Spall with exposed steel in near backwall

Backwalls; clean and patch spalls with exposed steel.

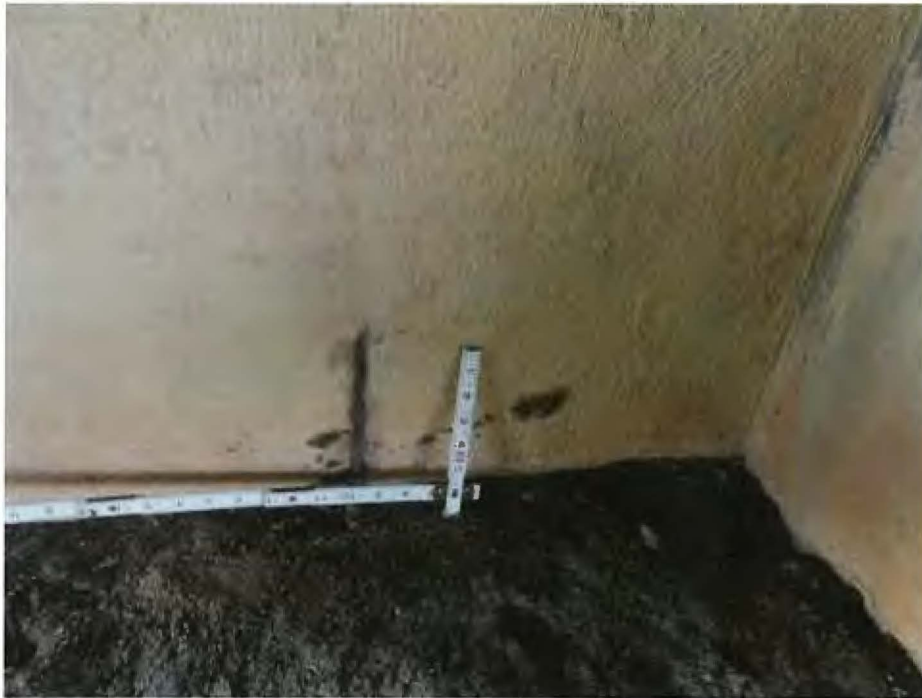
215 - Re Conc Abutment

2) The near backwall has a spall, 0.58 ft H x 0.17 ft W x 0.25 in D, at ground level between Piles 1-4 and 1-5, with exposed steel, 0.58 ft long, and 50% section loss (See Photo 9). (1090 - 1 FT)

Photo 9: Spall with exposed steel with section loss of near backwall

Backwalls; clean and patch spalls with exposed steel and section loss.

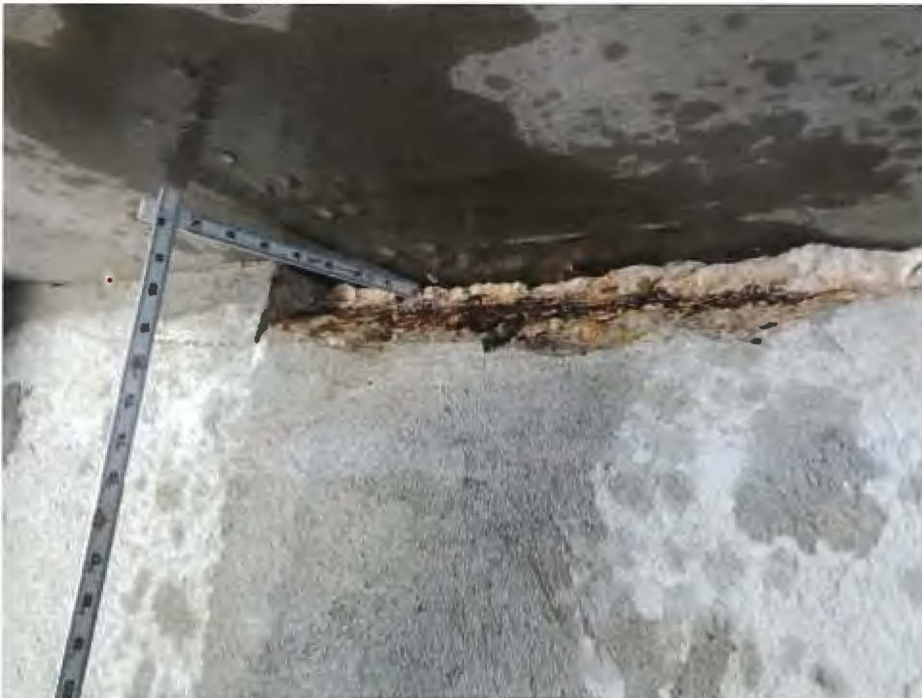
215 - Re Conc Abutment

3) The far backwall has a spall, 3.5 ft L x 0.25 ft W x 0.25 ft D, between Piles 7-3 and

7-4, with one piece of exposed steel and 30% section loss (See Photo 10). (1090 - 4 FT)  
 4) The far backwall has a spall, 0.50 ft H x 1.0 ft L x 0.08 ft D, with exposed steel (See Photo 11). (1080 - 1 FT)  
 5) Abutment Cap 7 has a spall, 0.67 ft L x 0.17 ft H x 0.50 in D, under Beam 4 (See Photo 12). (1080 - 1 FT)

Photo 10: Spall with exposed steel with section loss of far backwall

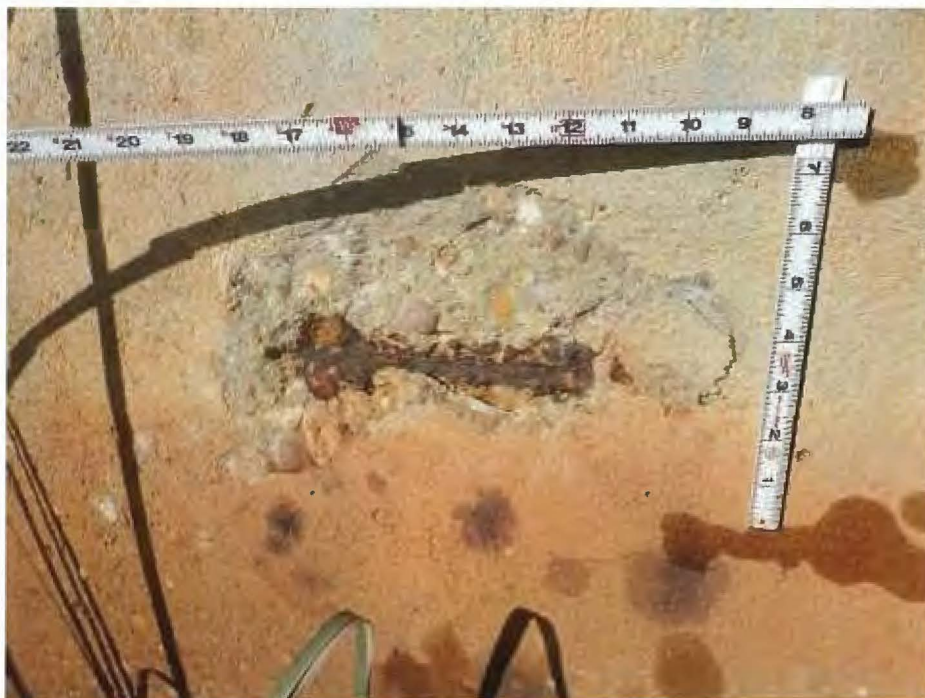
**215 - Re Conc Abutment**

Photo 11: Spall with exposed steel in far backwall

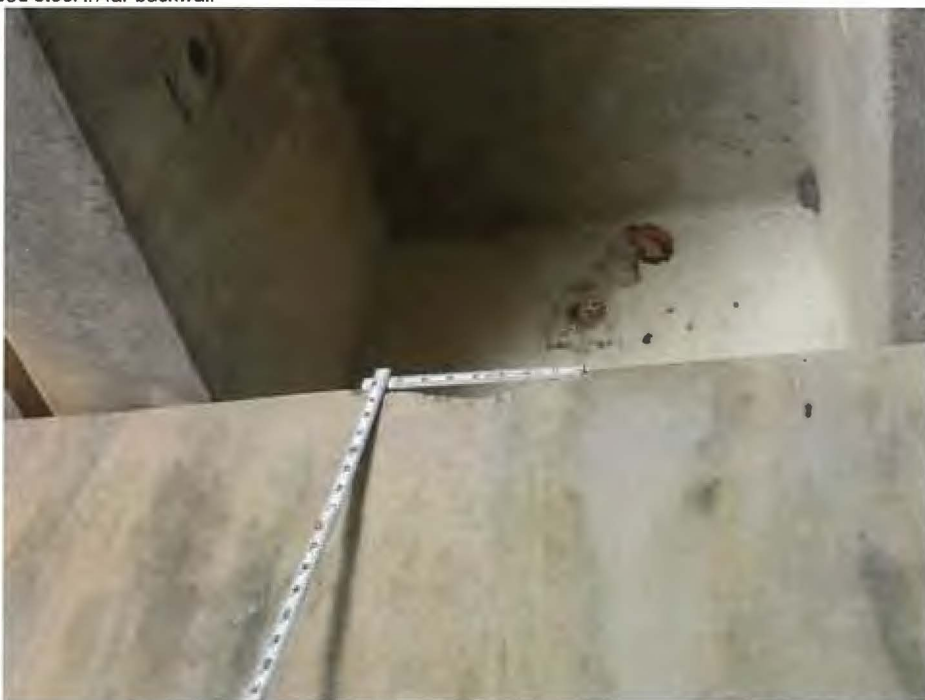
**215 - Re Conc Abutment**

Photo 12: Spall on Abutment Cap 7

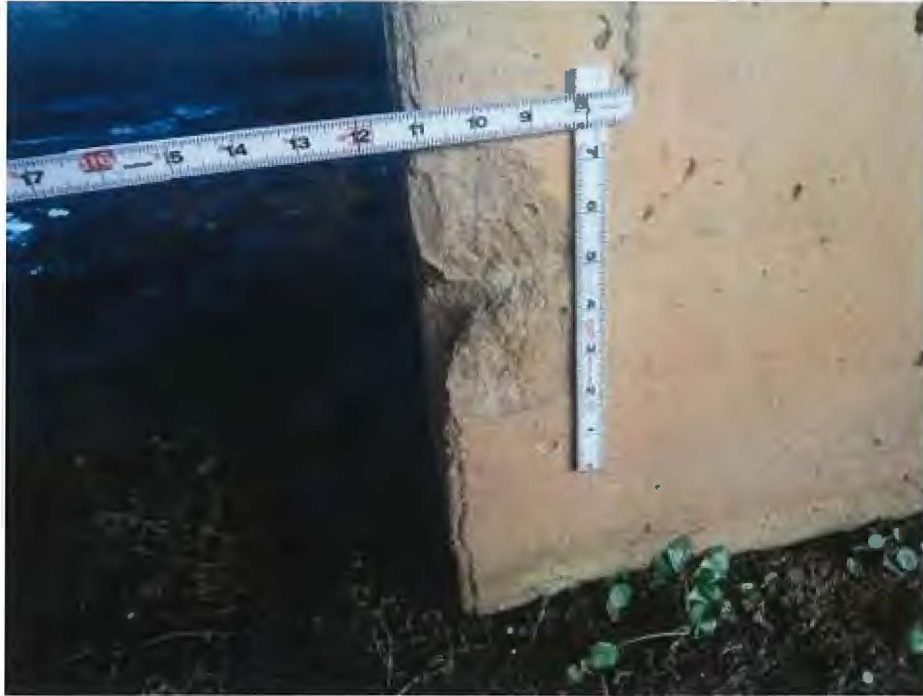
**227 - Re Conc Pile**

- 1) Pile 2-3 has a spall, 0.50 ft H x 0.21 ft W x 0.50 in D, 5.0 ft below the bent cap (See Photo 13). (1080 - 1 EA)
- 2) Pile 2-7 has a crack, 0.06 in wide, in the far left side (See Photo 14). (1130 - 1 EA)

- 4) Pile 3-4 has cracks, 0.06 in wide, in the left and right face with corrosion bleed out (See Photo 15). (1130 - 1 EA)
- 5) Pile 5-1 has a spall, 0.67 ft H x 0.17 ft W x 0.50 in D, 4.0 ft below the bent cap on the far right corner (See Photo 13). (1080 - 1 EA)

- 7) Pile 5-4 has a spall, 0.50 ft H x 0.25 ft W x 0.08 ft D, 5.0 ft below the bent cap on the far right corner (See Photo 13). (1080 - 1 EA)
- 8) Pile 5-6 has a failing patch, 0.33 ft H X 0.42 ft W, at the bent cap on the near right corner (See Photo 16). (1080 - 1 EA)

Photo 13: Typical spall on pile corner

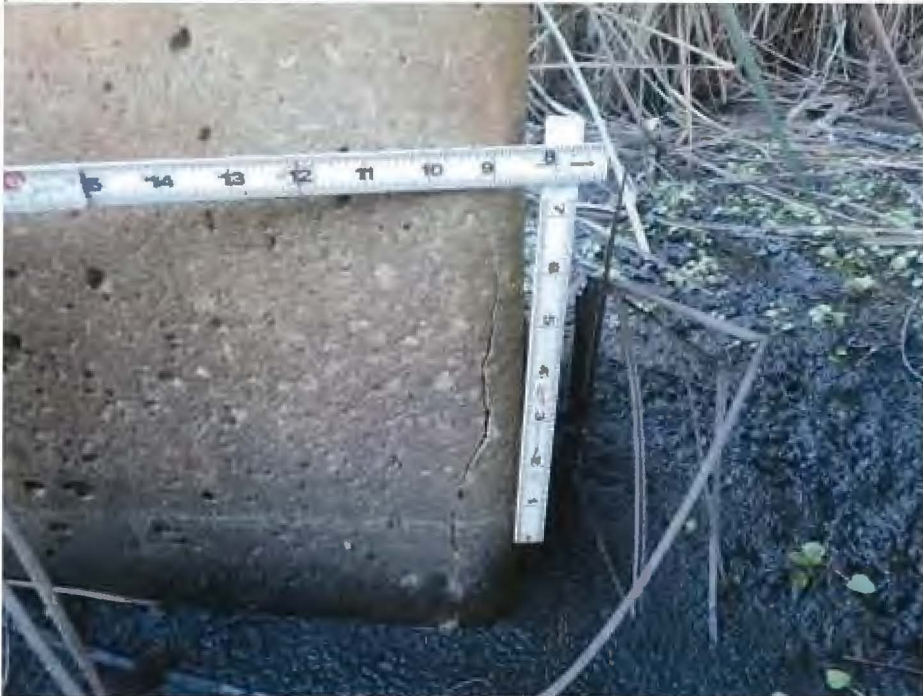
**227 - Re Conc Pile**

- 3) Piles 3-2, 3-3, 5-1 and 5-2 have a vertical cracks, 1.0 ft H x 0.06 in W, starting at the channel bottom on the right face (See Photo 14). (1130 - 3 EA)

- 10) Piles 7-1, 7-4, and 7-5 have a cracks, 1.0 ft H x 0.06 in W, starting at the channel bottom on the near face (See Photo 14). (1130 - 2 EA)
- 11) Pile 7-7 has a failing patch, 1.58 ft H x 0.33 ft W, in the far right corner adjacent to the far backwall (See Photo 16). (1080 - 1 EA)

Photo 14: Typical crack in pile

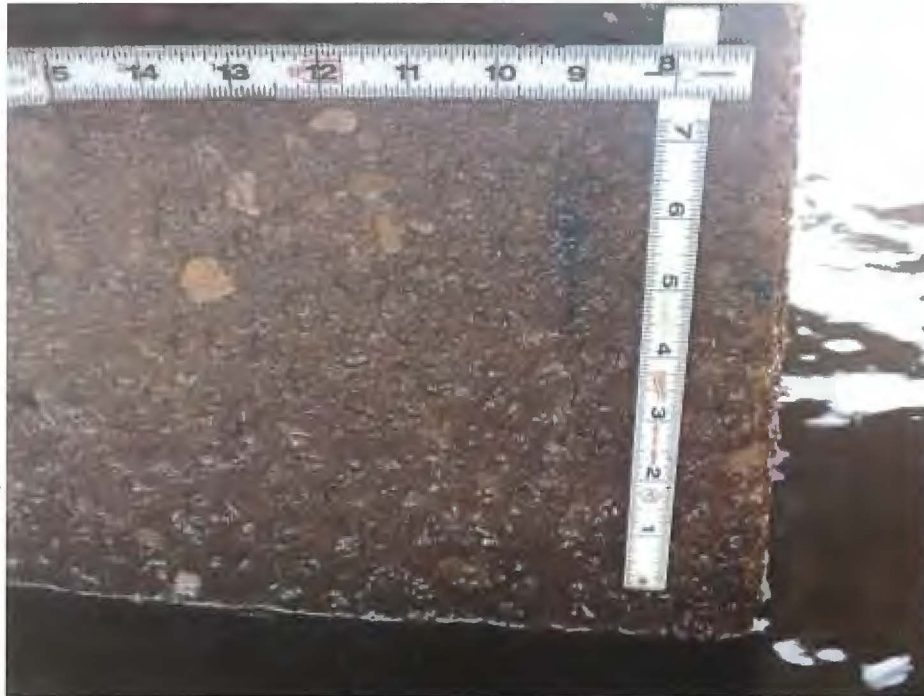
227 - Re Conc Pile

- 6) Pile 5-3 has a vertical crack, 1.0 ft H x 0.06 in W, starting at the channel bottom on the right face, with corrosion bleed out (See Photo 15). (1130 - 1 EA)

Photo 15: Typical crack with corrosion bleed out on pile

Piles 3-4 and 5-3; clean and epoxy inject cracks.

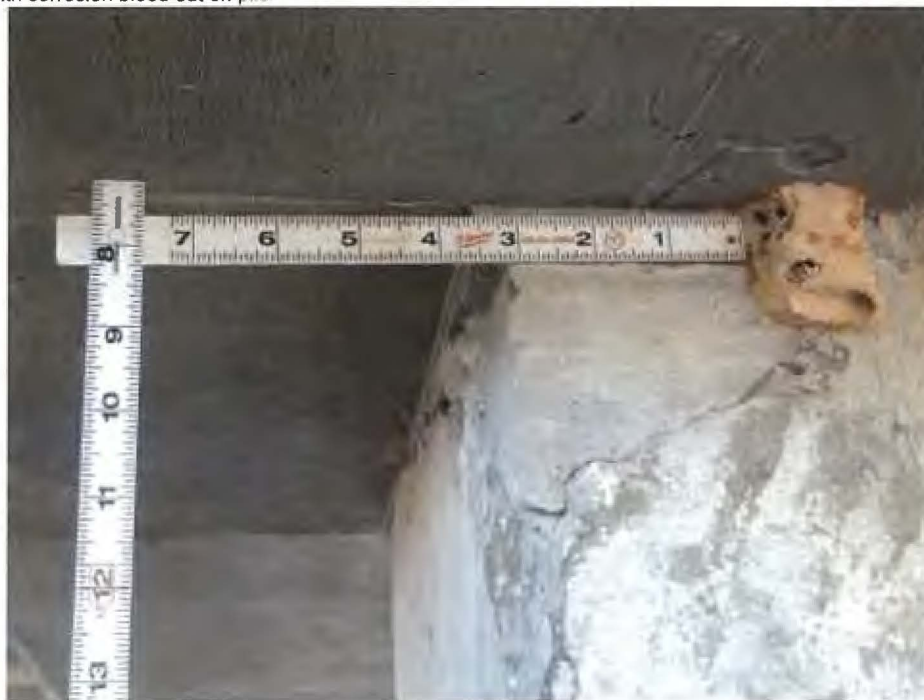
227 - Re Conc Pile

Photo 16: Typical failing patch on pile

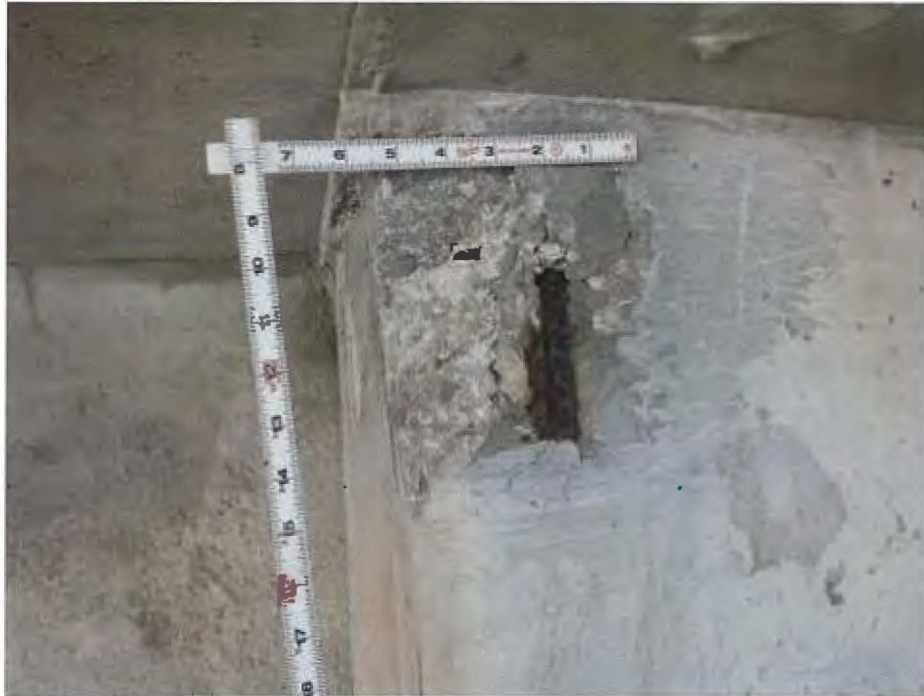
227 - Re Conc Pile

- 9) Pile 7-1 has a spall, 0.75 ft H x 0.50 ft W x 0.17 ft D, 0.50 ft below the bent cap on the near left corner, with one piece of exposed steel (See Photo 17). (1080 - 1 EA)

Photo 17: Spall with exposed steel on Pile 7-1

Pile 7-1; clean and patch spall with exposed steel.

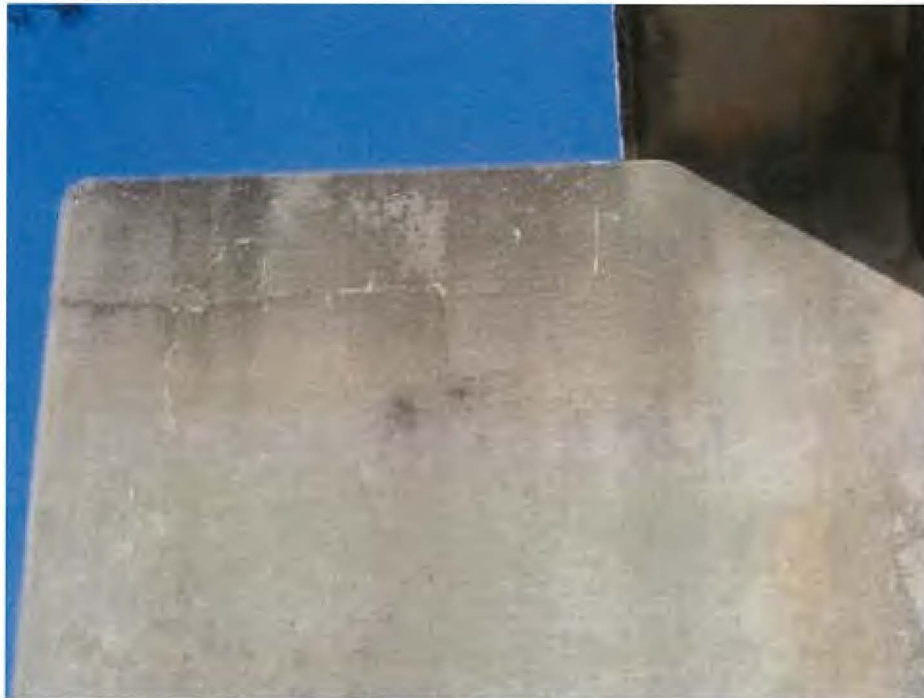
234 - Re Conc Pier Cap

1) The left end of Bent Cap 6 has a crack, 0.06 in wide, extending around the near and far faces (See Photo 18). (1130 - 10 FT)

Photo 18: Crack in left end of Bent Cap 6

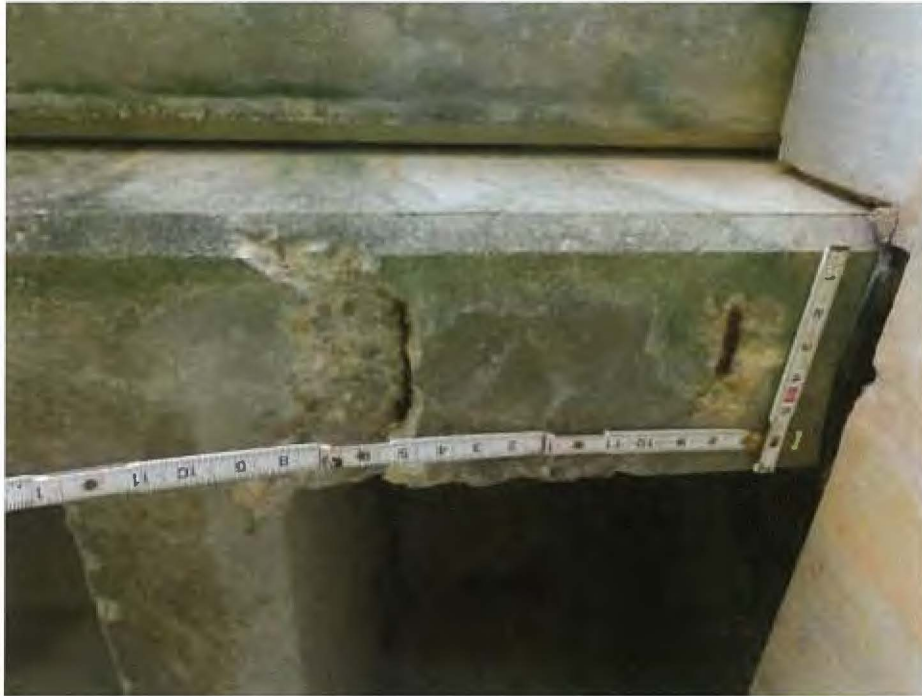
109 - Pre Opn Conc Girder/Beam

1) Beam 1-1, left leg has a spall, 0.33 ft L x 0.67 ft W x 0.08 ft D, adjacent to the abutment, with exposed steel, 0.33 ft long (See Photo 19). (1080 - 1 FT)

Photo 19: Spall with exposed steel in Beam 1-1

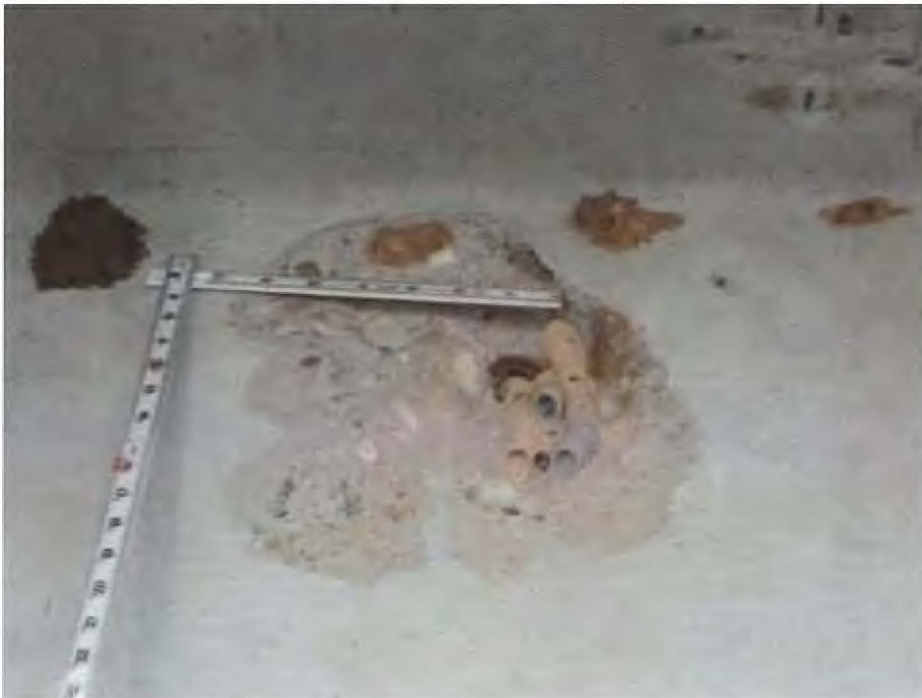
109 - Pre Opn Conc Girder/Beam

2) Beam 1-6, right leg has a spall, 1.0 ft H x 0.67 ft L x 0.17 (See Photo 20). (1080 - 1 FT)

Photo 20: Spall on Beam 1-6

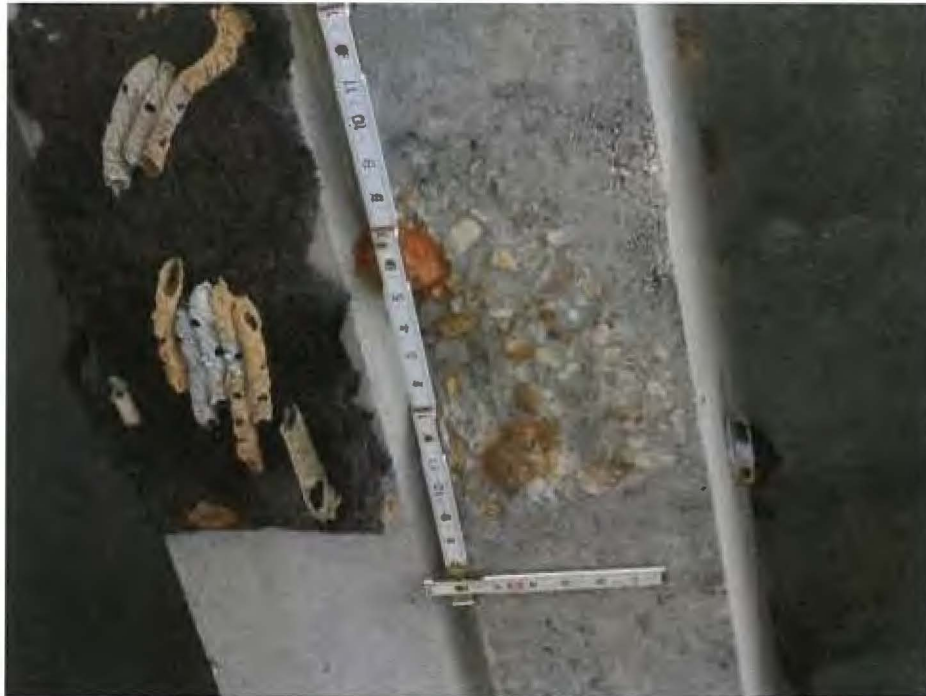
**109 - Pre Opn Conc Girder/Beam**

3) Beam 1-8, left leg has a spall, 0.92 ft L x 0.67 ft W x 0.08 ft D, at Bent Cap 2 in the bottom face (See Photo 21). (1080 - 1 FT)

Photo 21: Spall in bottom face of Beam 1-8

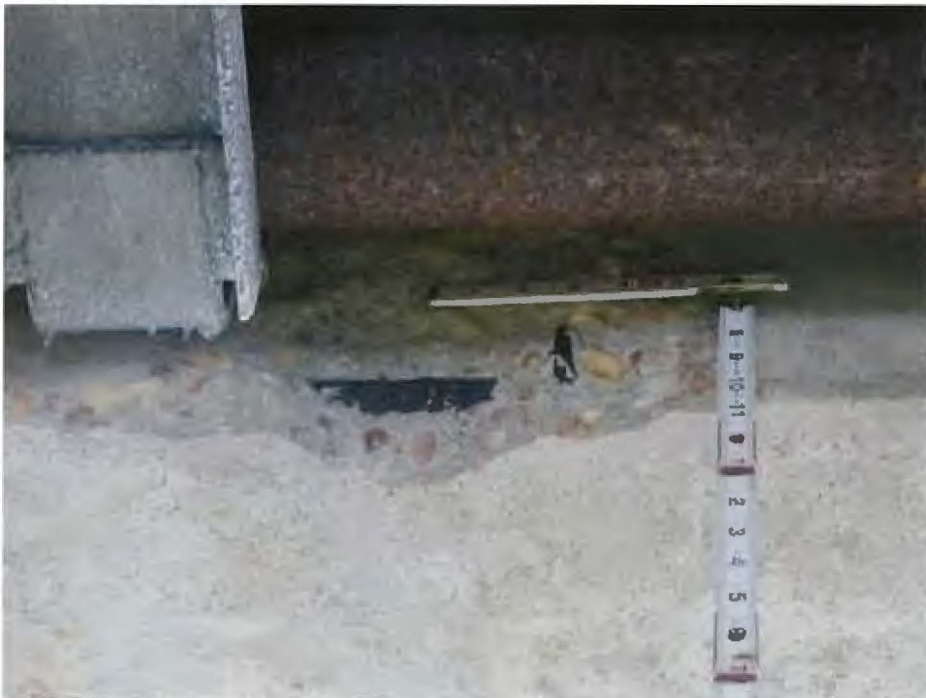
**109 - Pre Opn Conc Girder/Beam**

- 4) Beam 2-11, left leg has a spall, 0.83 ft H x 0.17 ft L x 0.17 ft D, 5.0 ft from Bent Cap 3 in the left face, with two pieces of exposed steel, up to 0.17 ft long, with no section loss (See Photo 22). (1080 - 1 FT)

- 5) Beam 4-5, right leg has a spall, 0.83 ft L x 0.58 ft W x 0.50 in D, 7.0 ft from Bent Cap 4 in the bottom face, with two pieces of exposed steel (See Photo 22). (1080 - 1 FT)

Photo 22: Typical spall with exposed steel in beam

CONDITION STATE		PRIORITY
3	MMS Quantity: 1 mh    Element Estimated Quantity: 27 ft	3
WORK ORDER RECOMMENDATION: Beams 2-11 4-5 and 5-12; clean and patch spalls with exposed steel.

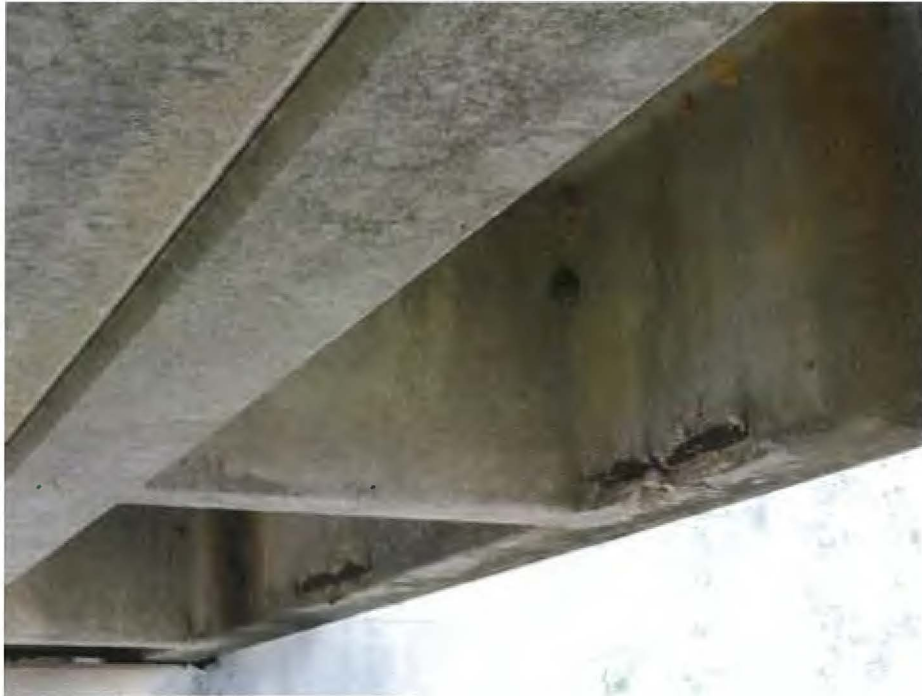
109 - Pre Opn Conc Girder/Beam

- 7) The bottom left face of Beam 4-12 has a spall/delamination, full length x 0.58 ft H x 0.13 ft D, with two areas of exposed steel, 2.0 ft long, with 10% section loss (See Photo 23). (1090 - 40 FT)

Photo 23: Typical spall/delamination with exposed steel and section loss in Beam 4-12

CONDITION STATE		PRIORITY
3	MMS Quantity: 1 mh    Element Estimated Quantity: 40 ft	3
WORK ORDER RECOMMENDATION: Beam 4-12; clean and patch spall with exposed steel and section loss.

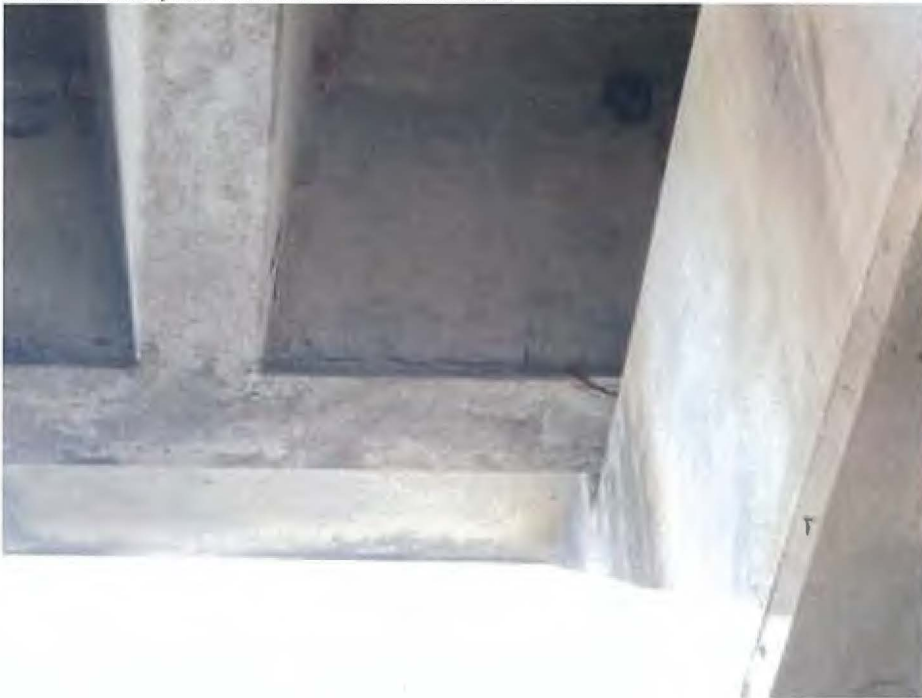
109 - Pre Opn Conc Girder/Beam

- 6) Beam 5-1, left leg has a longitudinal crack, 0.13 in wide, adjacent to midspan diaphragm and extending to the bent cap, with corrosion bleed out (See Photo 24). (1130 - 5 FT)

Photo 24: Longitudinal crack with corrosion bleed out along Beam 5-1

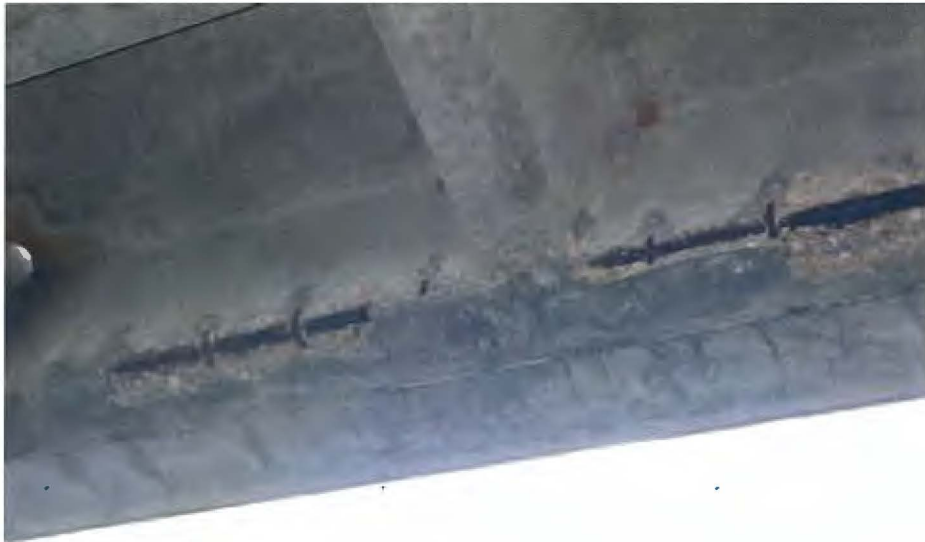
**109 - Pre Opn Conc Girder/Beam**

- 8) Beam 5-12, right leg has a spall/delamination, 25.0 ft L x 0.83 ft H x 0.17 ft D, with seven exposed stirrups and one longitudinal piece of rebar (See Photo 25). (1080 - 25 FT)

Photo 25: Typical spall/delamination with exposed steel along Beam 5-12

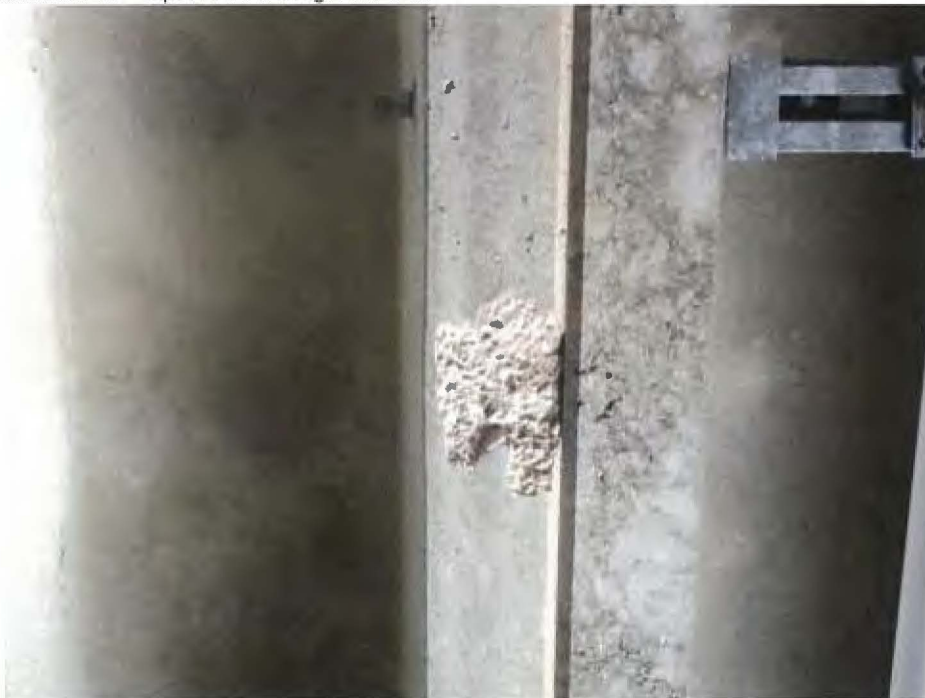
**109 - Pre Opn Conc Girder/Beam**

- 9) Beam 6-4, right leg has a spall, 1.5 ft L x 0.50 ft W x 0.08 ft D, 15.0 ft from Bent Cap 6 (See Photo 26). (1080 - 2 FT)

Photo 26: Spall in bottom face of Beam 6-4

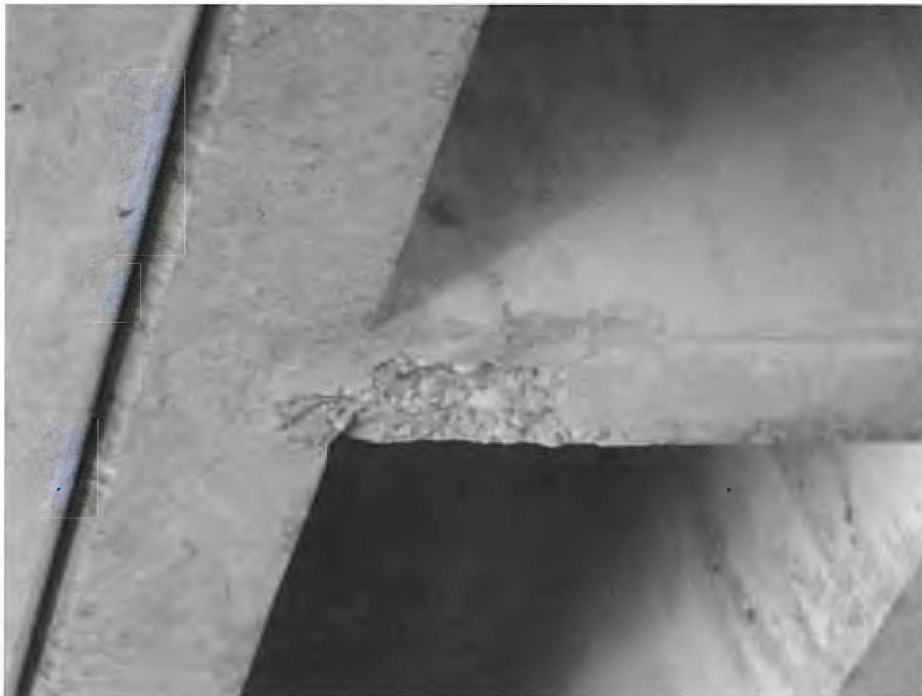
**109 - Pre Opn Conc Girder/Beam**

- 1) The diaphragm of Beam 1-3 is delaminated, 2.08 ft W x 1.08 ft H, adjacent to the near abutment.
- 2) The midspan diaphragm of Beam 3-8 has a delamination, 0.25 ft H x 1.17 ft W, in the near face.
- 3) The midspan diaphragm of Beam 5-5 has a spall, 0.42 ft L x 0.83 ft W x 0.50 in D, in the bottom face (See Photo 27).
- 4) The midspan diaphragm of Beam 5-8 has a spall/delamination, 0.42 ft L x 0.83 ft W, in the bottom face (See Photo 27).

Photo 27: Typical spall/delamination in diaphragm of beam
